Conservation Management Plan

Cumberland Place and Steps

State Heritage Register 01542

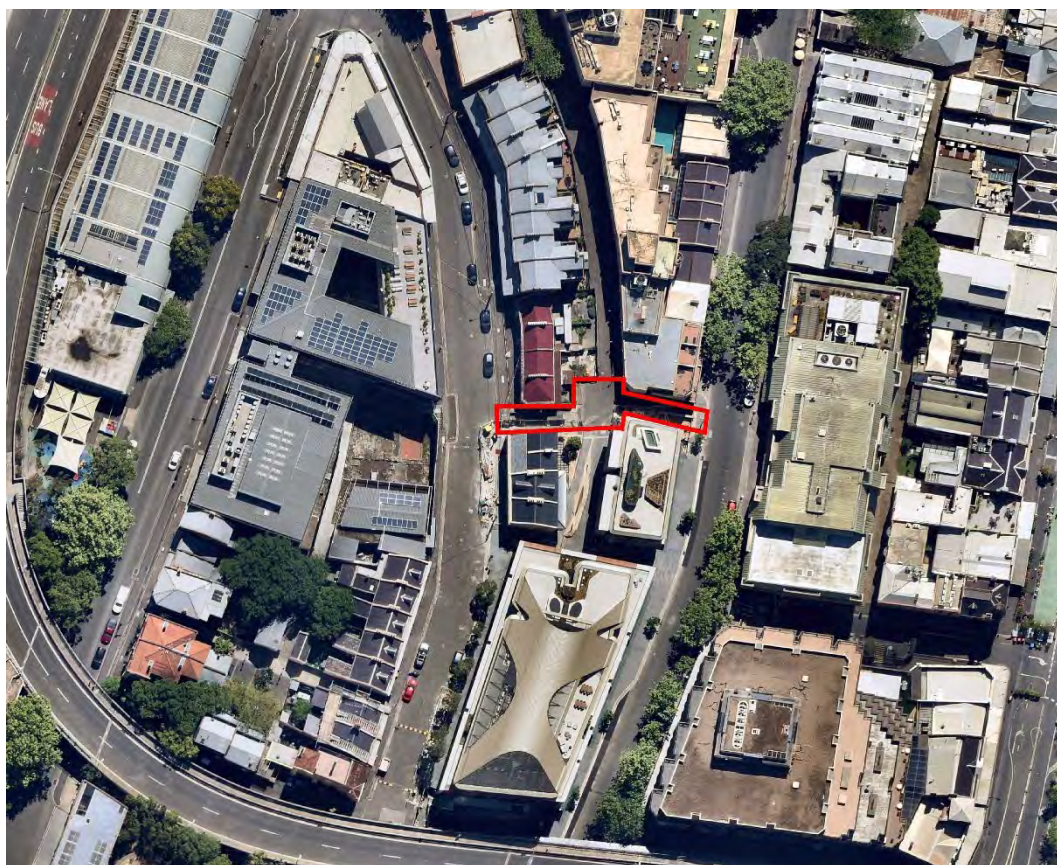
Figure 2: Aerial photo of Cumberland Place and Steps shown outlined in red. Source: nearmap with HAA overlay.

The site consists of a thoroughfare across Gloucester Street, Cambridge Street and Harrington Street comprised of four staircases and related landings. The current site is bounded by Gloucester Street, Cambridge Street and Harrington Street, Susannah Place, Baker's Terrace and 85 Harrington Street. (See figure 2)

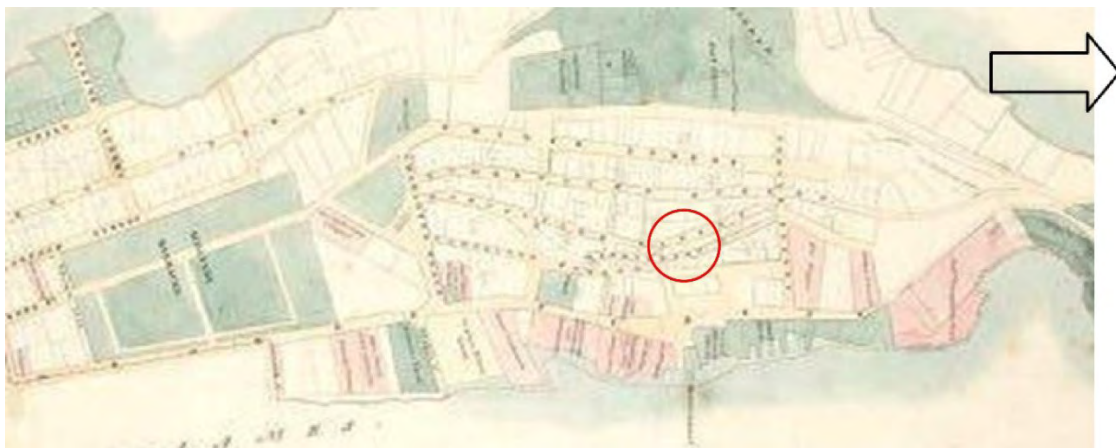
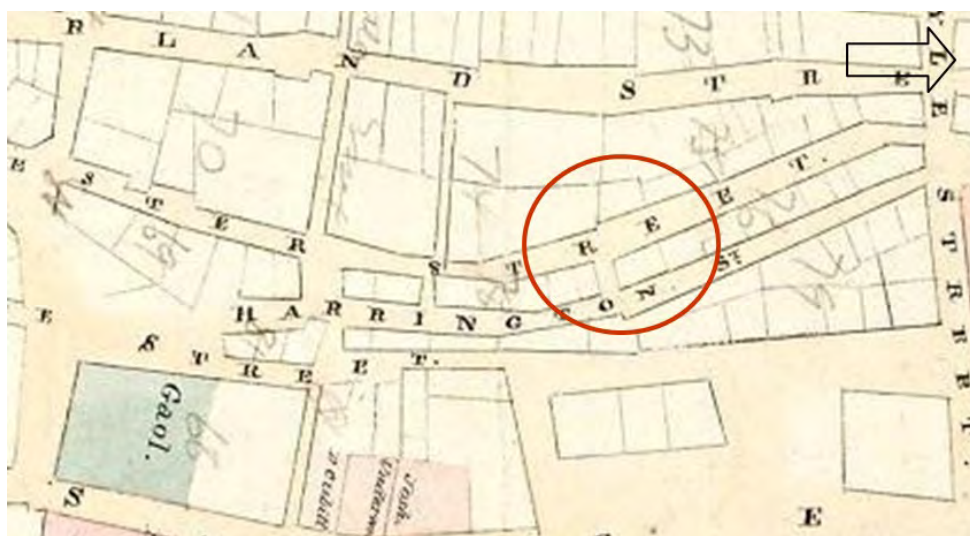
Figure 13 Top: 1831 Department of Lands Parish Map, St Phillips, edges cropped. Bottom: 1831 Department of Lands Parish Map, St Phillips. Note Cumberland Place between Harrington and Gloucester Street (above the "O" in Harrington).

The earliest plan showing a clearly delineated thoroughfare between Harrington and Gloucester Streets in the location of Cumberland Place is the 1831 Parish Map of Saint Phillip (Figure 13), where it is marked as a thoroughfare between Harrington and Gloucester Streets. Cribbs Lane west of Gloucester Street is not shown, but a property boundary in its location has been drawn onto the map. An 1834 land claim published in the NSW Government Gazette described the allotment claimed by James Byrne, victualler of Gloucester Street, as "...situate[d] at the junction of Gloucester-street and Gloucester-lane, formerly called Cribb's Lane..." This confirms both the name and the official recognition of at least part of the alignment of Cumberland Place by 1834, while also revealing an alternate name for the thoroughfare as Gloucester Lane.⁵

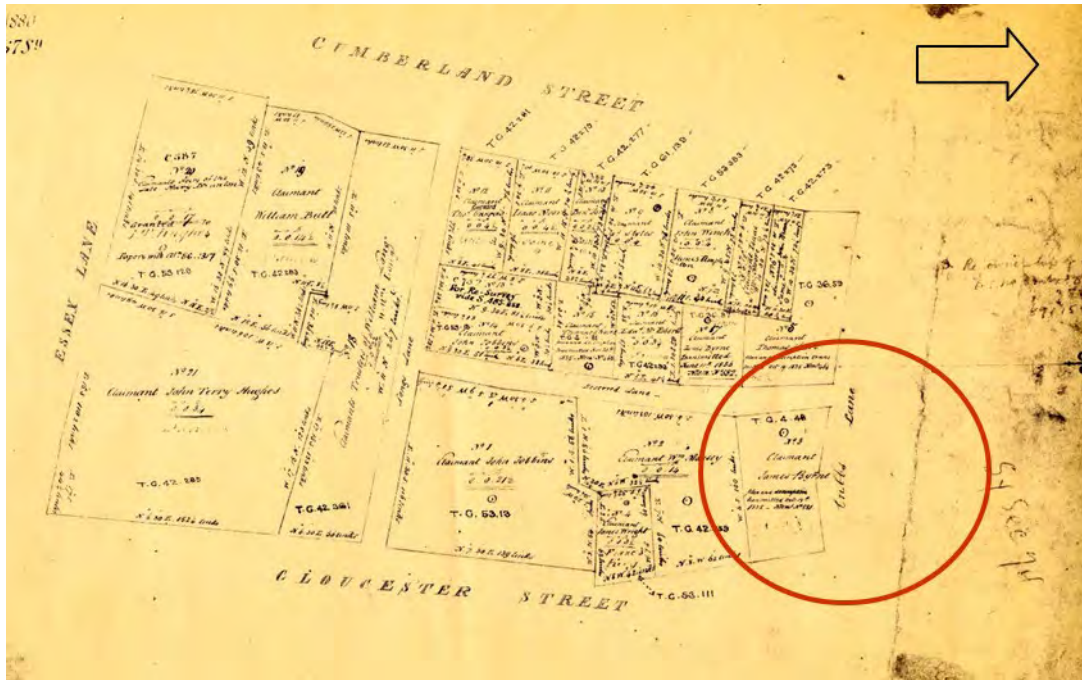
Figure 14 1838 Plan of Section 74. Note Cribbs Lane.

An 1838 plan of Sydney (Figure 14) is the earliest known official plan that shows the name 'Cribbs Lane' between Cumberland and Gloucester Streets. In the 1840s, the gaol moved from its site on George Street to Darlinghurst, and the original gaol building was demolished. A plan was drawn up to show the land of the gaol and the 'Proposed Realignment of Harrington Street' (Figure 15). The plan shows a 'Proposed Lane' where Cumberland Place is now. This laneway is believed to have been already in existence by that date, so this plan could be the instrument used to formalise the thoroughfare. Similarly, Globe Street, which was also depicted in some earlier maps and plans, is here marked as a 'Proposed Street', indicating that in 1848 it had not been officially recognised.

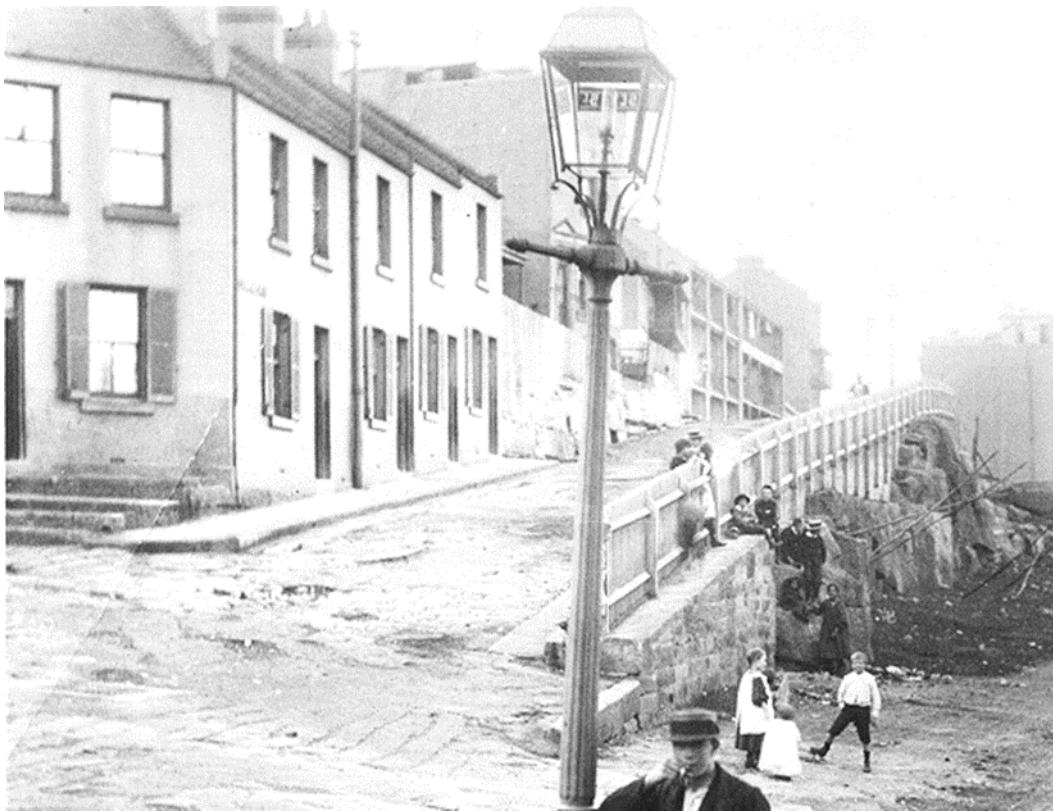
Figure 22 1901 configuration of Harrington Street, viewed from the corner of Essex Street. Note retaining wall along Harrington Street.

The set of stairs from Harrington Street (“A”) may have been constructed c. 1905. As Harrington Street was realigned and levelled about that year, it is very likely that the stairs were built at the same time. These early stairs from Harrington Street were much narrower than those that exist today. They were widened to twice their original width during the 1970s. Due to wear, the older side of the Harrington Street steps were fenced off and the other side capped with concrete in the 1990s. The stairs from Harrington Street (“A”) were widened in the 1970s.

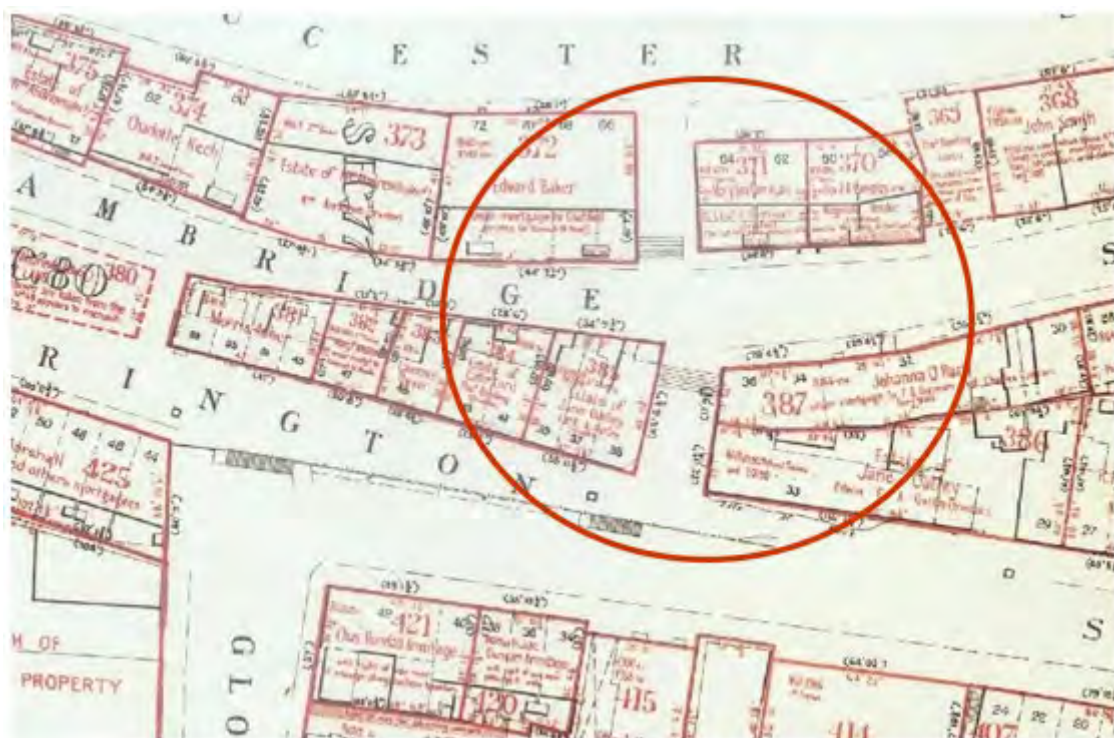
Figure 23 1901 Darling Harbour Resumption Plans, Plan O. Detail showing Cumberland Place. Situation shown matches that shown in Figure 21. The uppermost set of stairs would have been added a short time after this survey (cf. Figure 27).

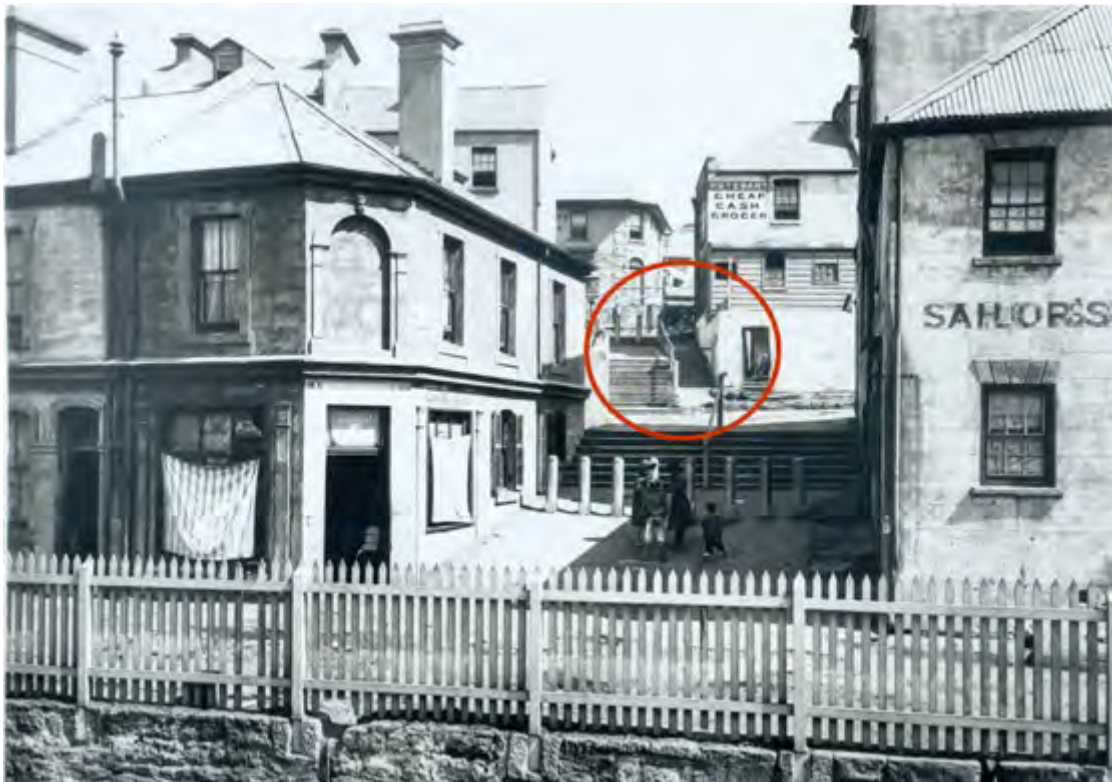
Figure 27 1901, Cumberland Place from Harrington Street. Note that there were no direct stairs from Harrington Street. Harrington Street was divided into two levels and a staircase was located south of Cumberland Place (to the left of the frame). The two steps to Cumberland Street (in the distance) were not shown in historic plans, including those created around this date. Note the goat protruding its head from the rear of yard of Susannah Place (circled) and posts fitted to prevent carts from going down the steps.

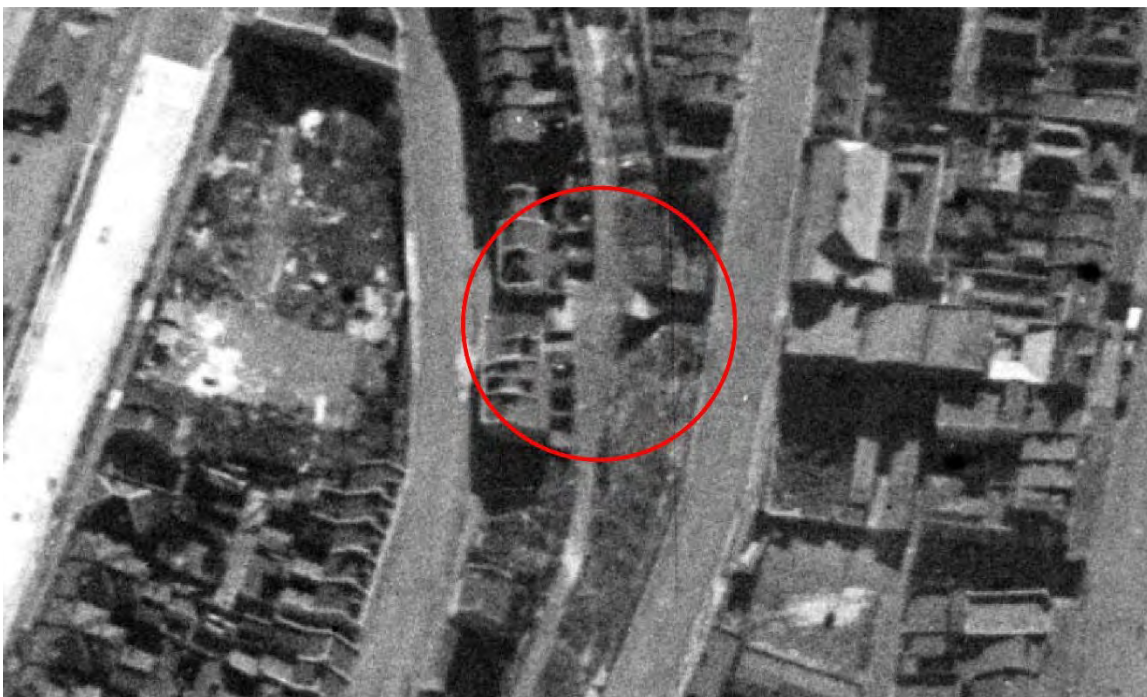
Figure 29 1943 aerial of Cumberland Place and Steps. Source: Sixmaps with HAA overlay.

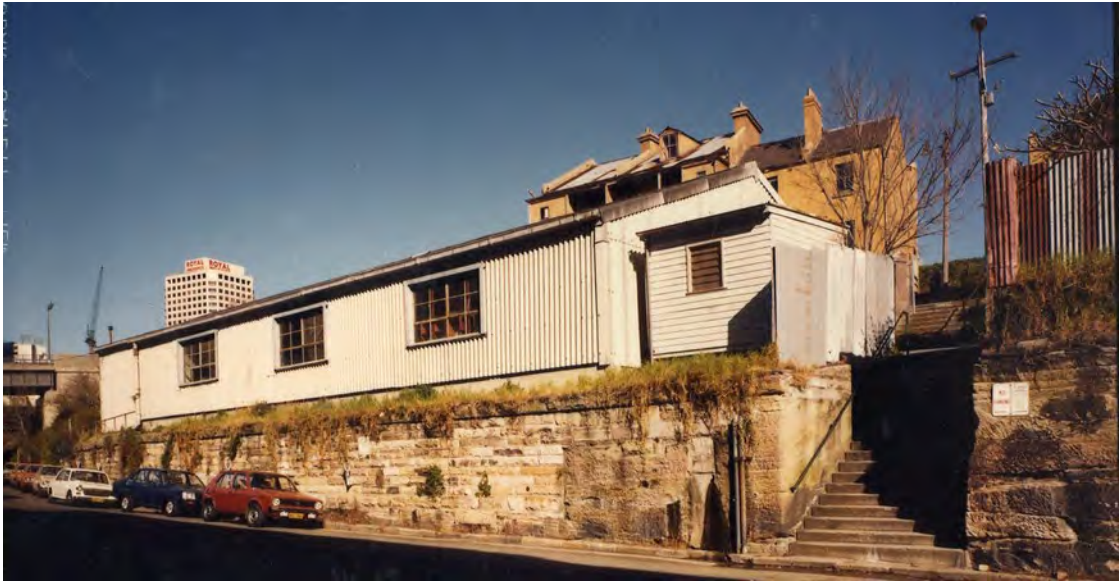
Figure 33 Harrington Street, 1980. Note the width of the stairs leading to Cumberland Place. Compare Figure 36.

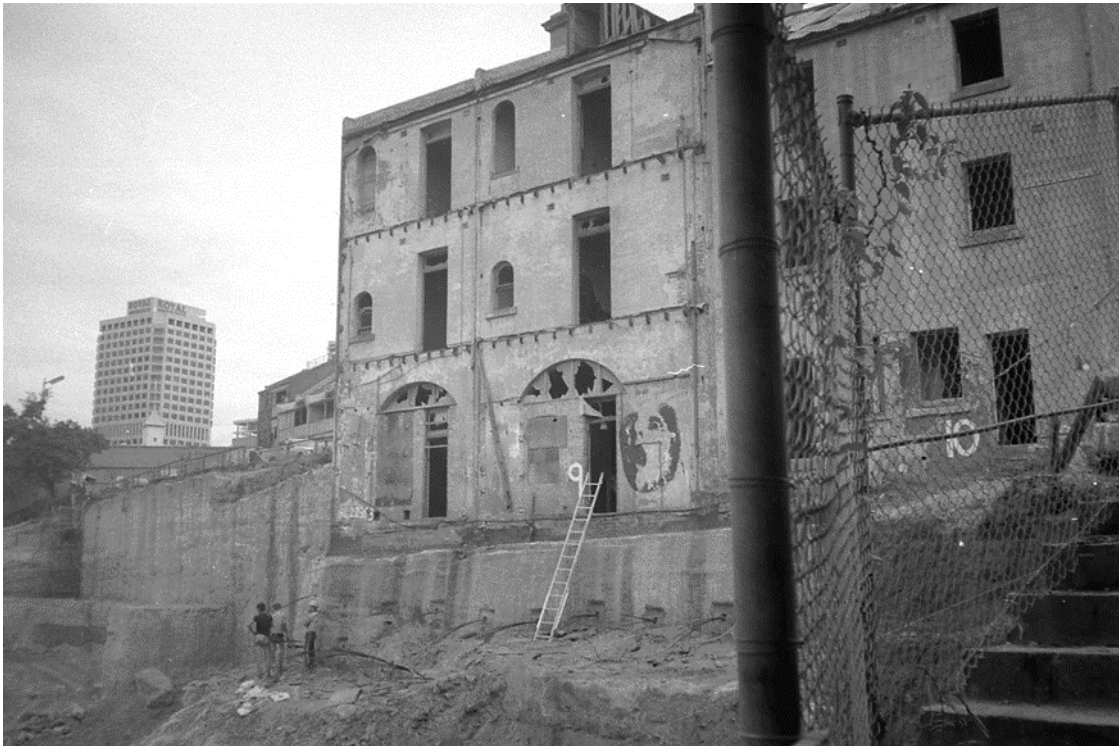
Figure 34 Photo of the rear of Baker's Terrace c. 1988, showing the extensive demolition and excavation which was undertaken at the rear of the buildings and the excavation in this area of the Cumberland Place.

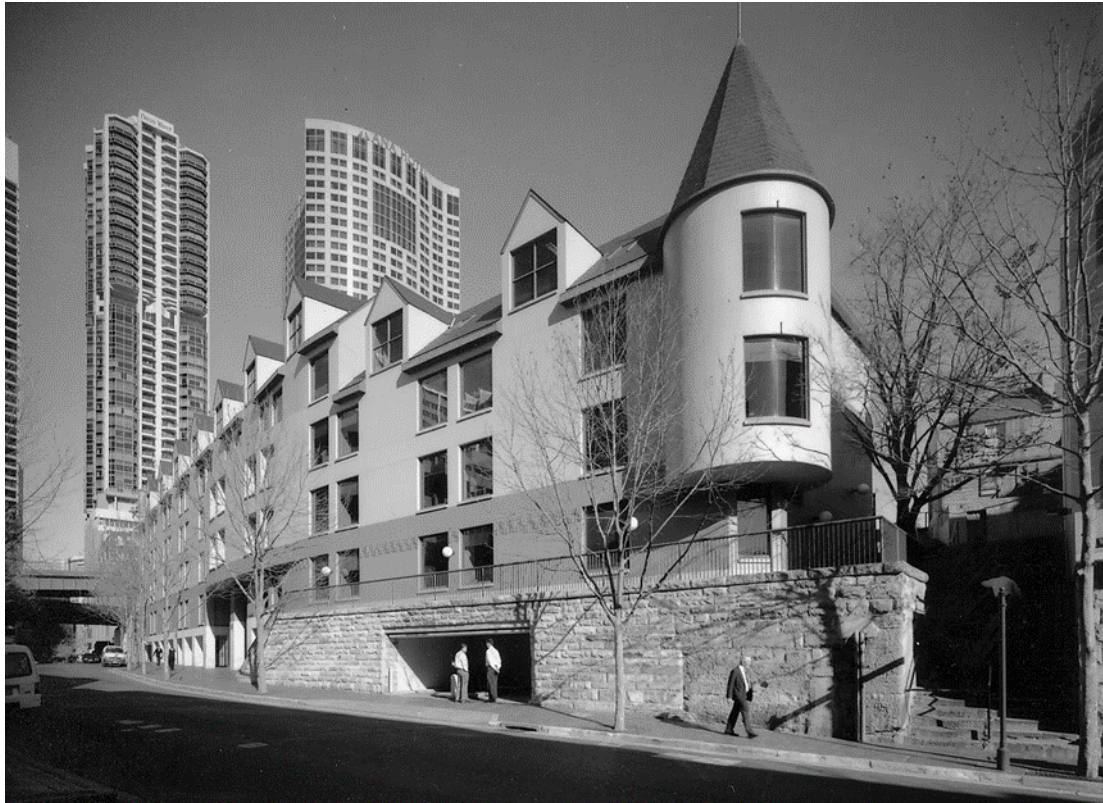
Figure 35 Harrington Street, 2001, QBE Office Building. Compare Figure 33, Figure 36 and Figure 27. Note Separation in the stairs.

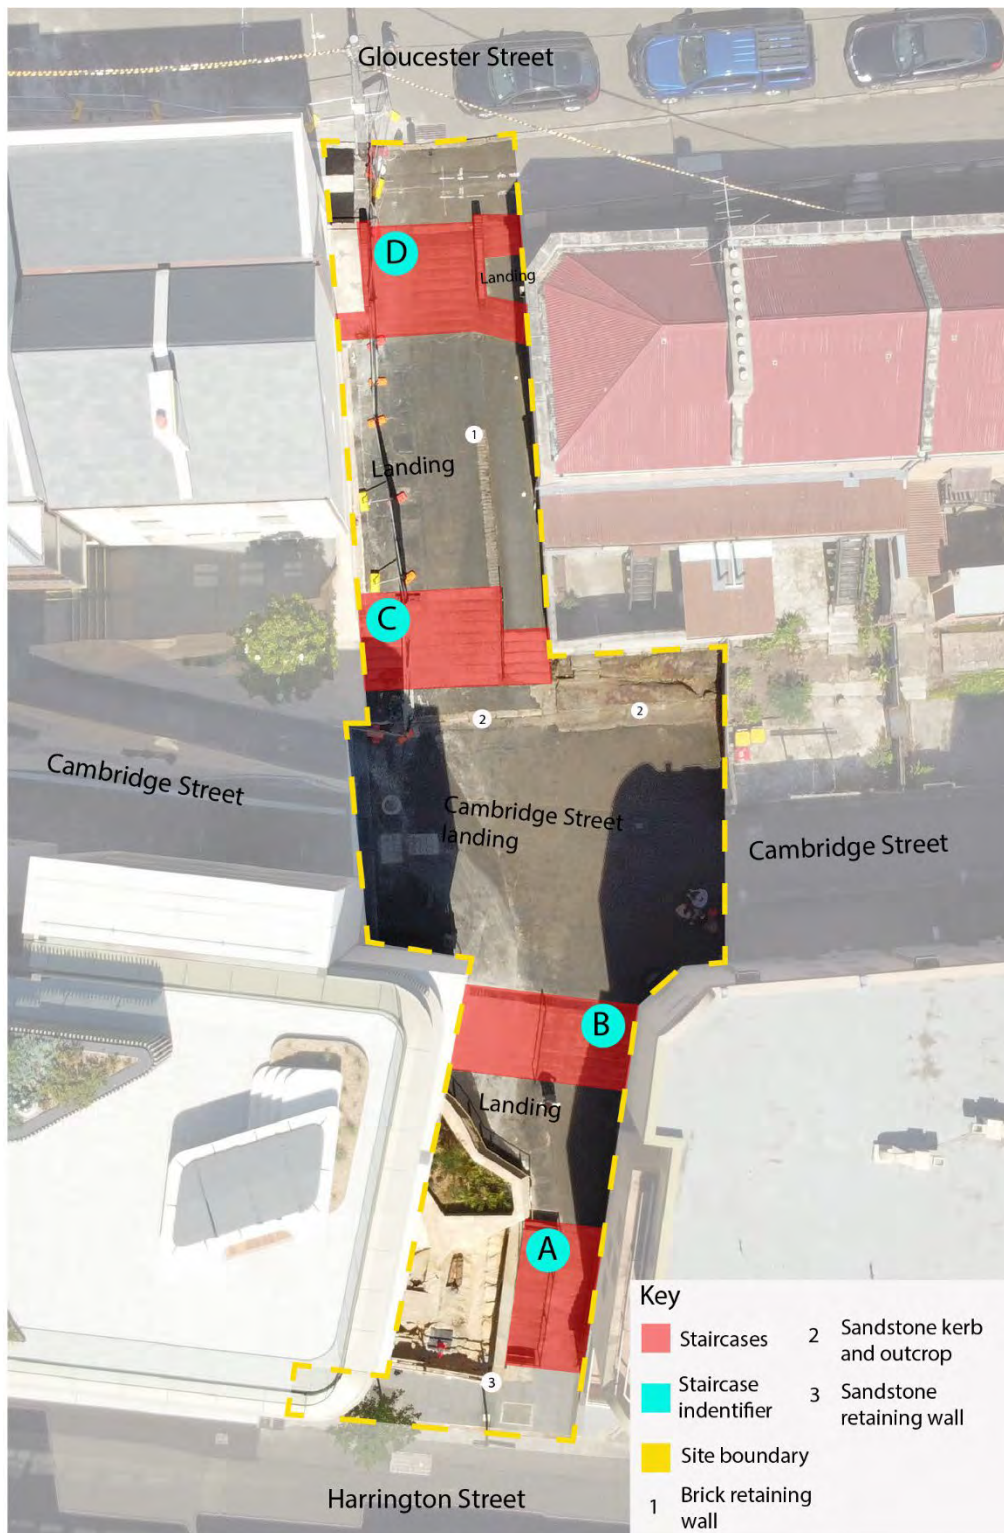
Figure 52 Aerial of Cumberland Place and Steps with elements and adjacent streets labelled.

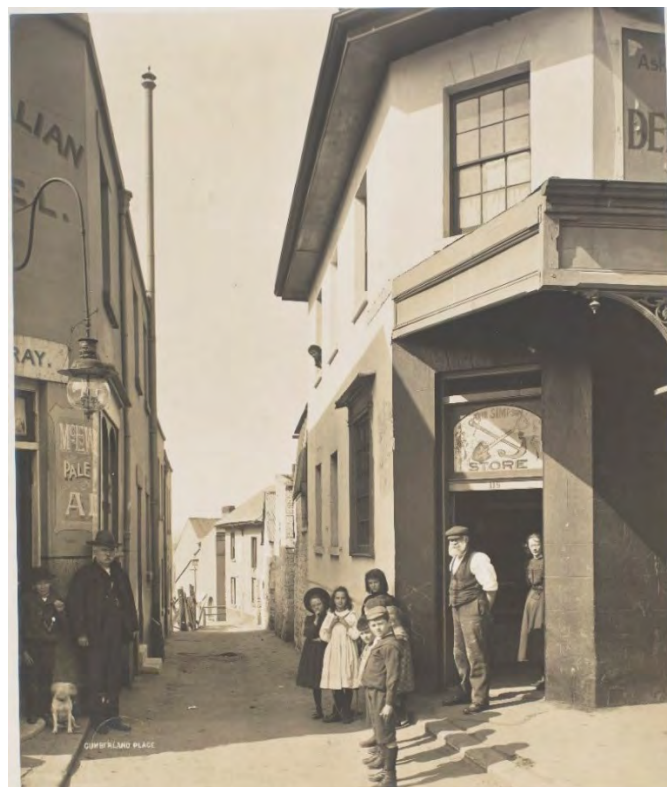
Figure 53: Cumberland Place (1901-1910) from Cumberland Street, The Rocks with a view to the north elevation of Bakers Terrace.
Source State Library of NSW.

1. A photograph taken between 1901 and 1910 from Cumberland Street looking down Cumberland Place (Cribbs Lane), reveals a line of vision to the north elevation of Bakers Terrace (Figure 53).
2. Another photograph (Figure 54) taken in 1901 from Harrington Street reveals a clear line of vision to the Whalers Arms Hotel located at the corner of Gloucester Street and Cumberland Place (Cribbs Lane).
3. Photographs from the 1970s and 1980s reveals a view to the Harbour Bridge from Cumberland Place, Cambridge Street landing (Figure 55). It is unclear how historic this view is, and if it has existed since the bridge's construction. A 1943 aerial does not appear to show development which could obscure the view (Figure 29).

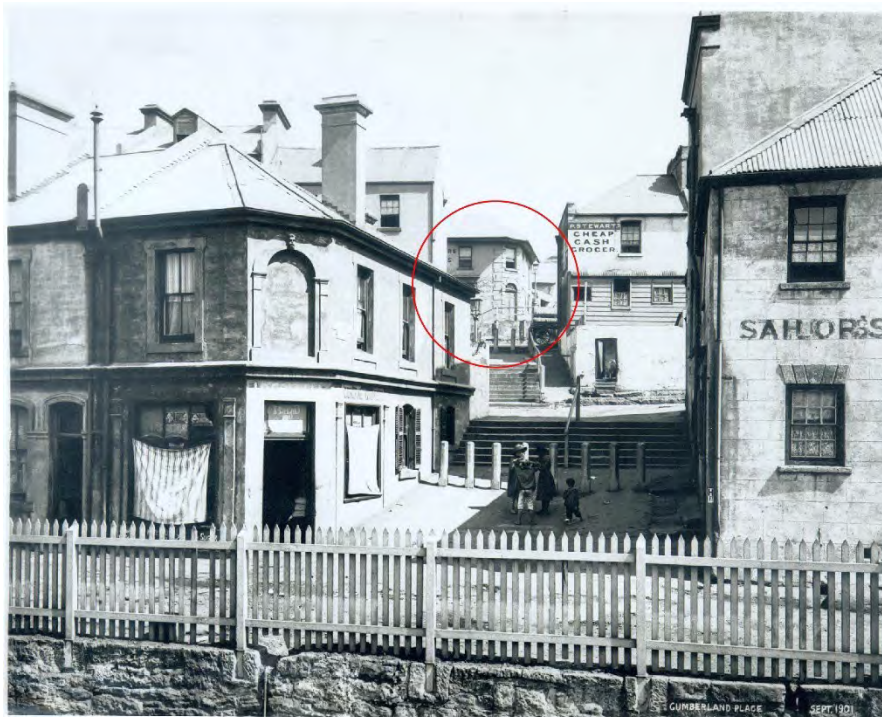
Figure 54: Cumberland Place (1901) from Harrington Street with a view to the Whalers Arms Hotel. Source: Place Management NSW.

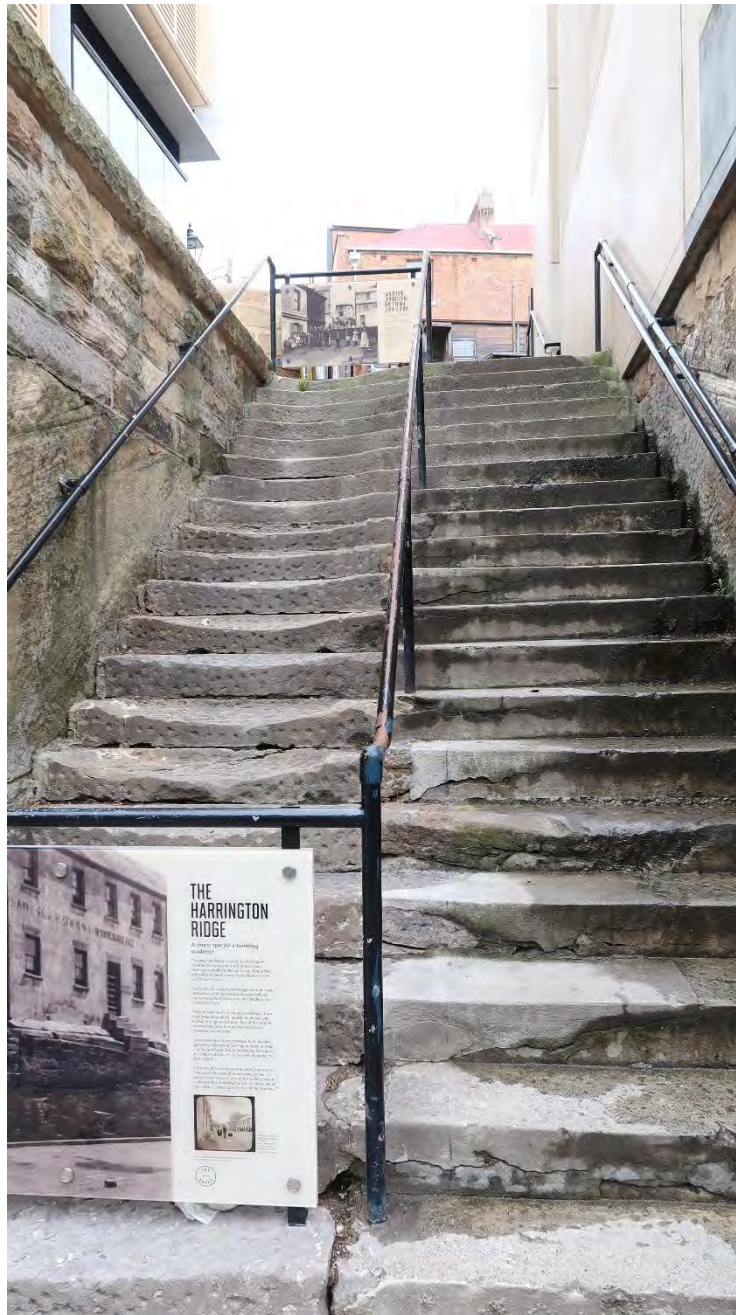
Figure 57 Susannah Place visible from the bottom of staircase A, Harrington Street.

1. View to Susannah Place from the Harrington Street entrance from staircase A (Figure 57).
2. Views to Cribbs Lane (Big Dig Archaeological Site) Gloucester Street entrance from Cambridge Street landing (Figure 58).
3. South elevation and rear of 46-56 Gloucester Street (Edwardian Cottages) from Cambridge Street landing and staircase B (Figure 59).
4. Partial view down Cambridge Street from Cambridge Street landing.
5. Views to Harrington Street from landing between staircase C and D and the top of staircase D (Figure 60).

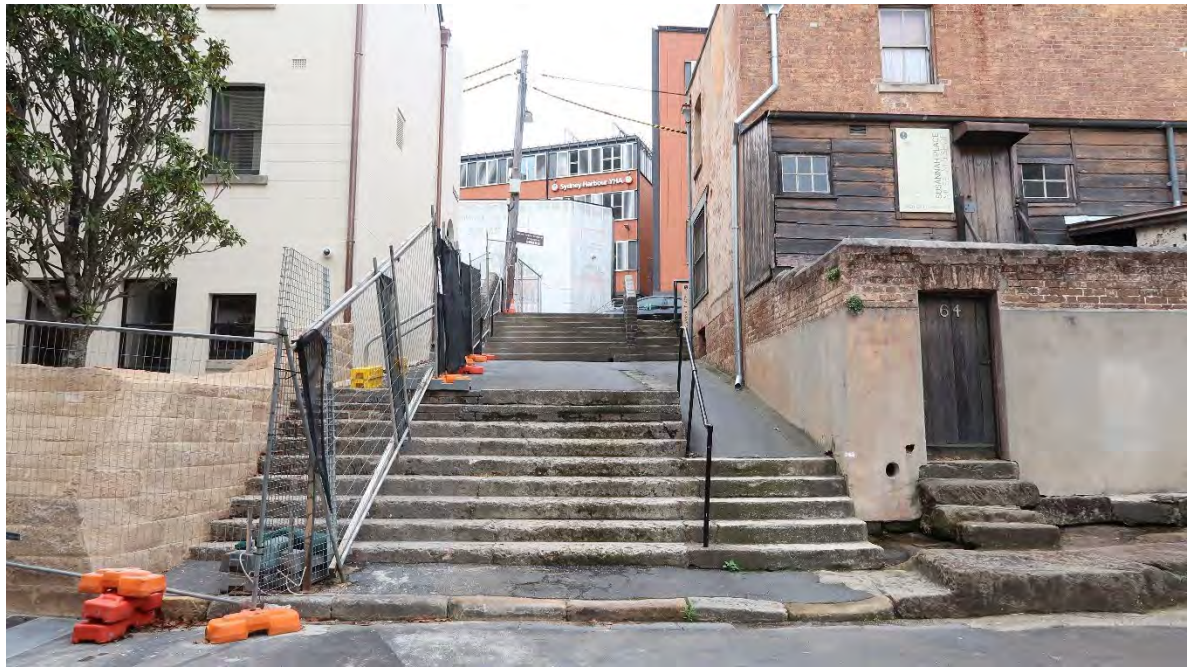
Figure 58 The Big Dig Site and start of Cribbs Lane is visible from Cambridge Street landing.

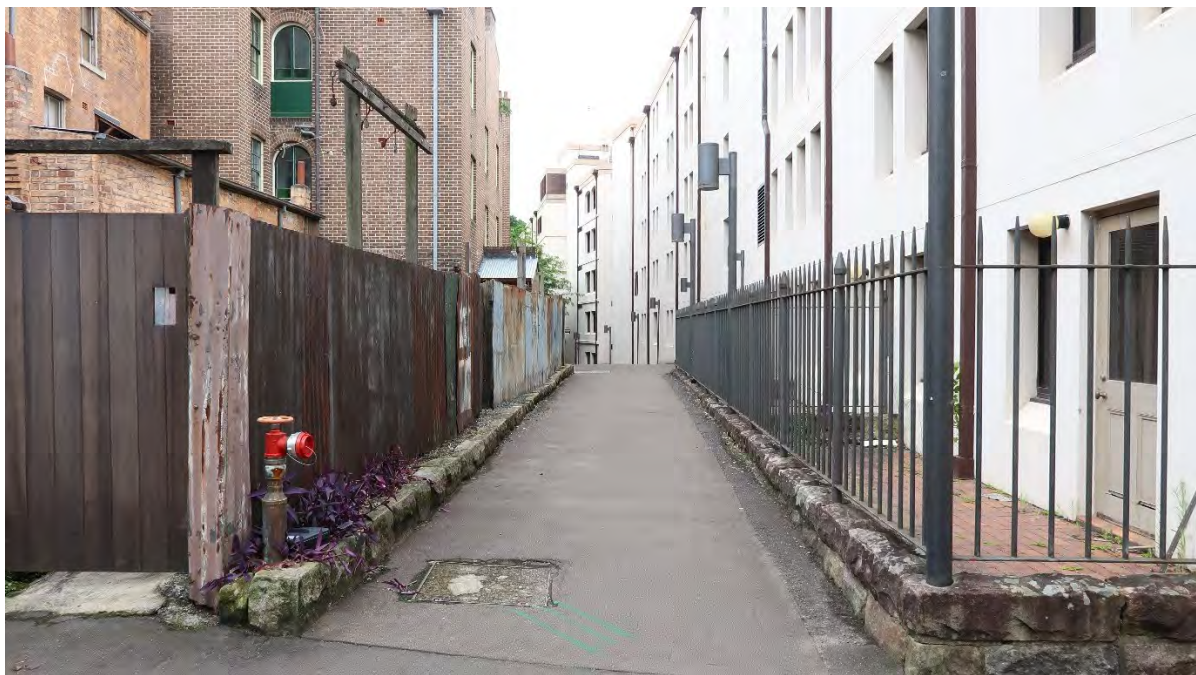
Figure 59 View down Cambridge Street and the rear of the Edwardian Cottages on Gloucester Street from Cambridge Street landing.

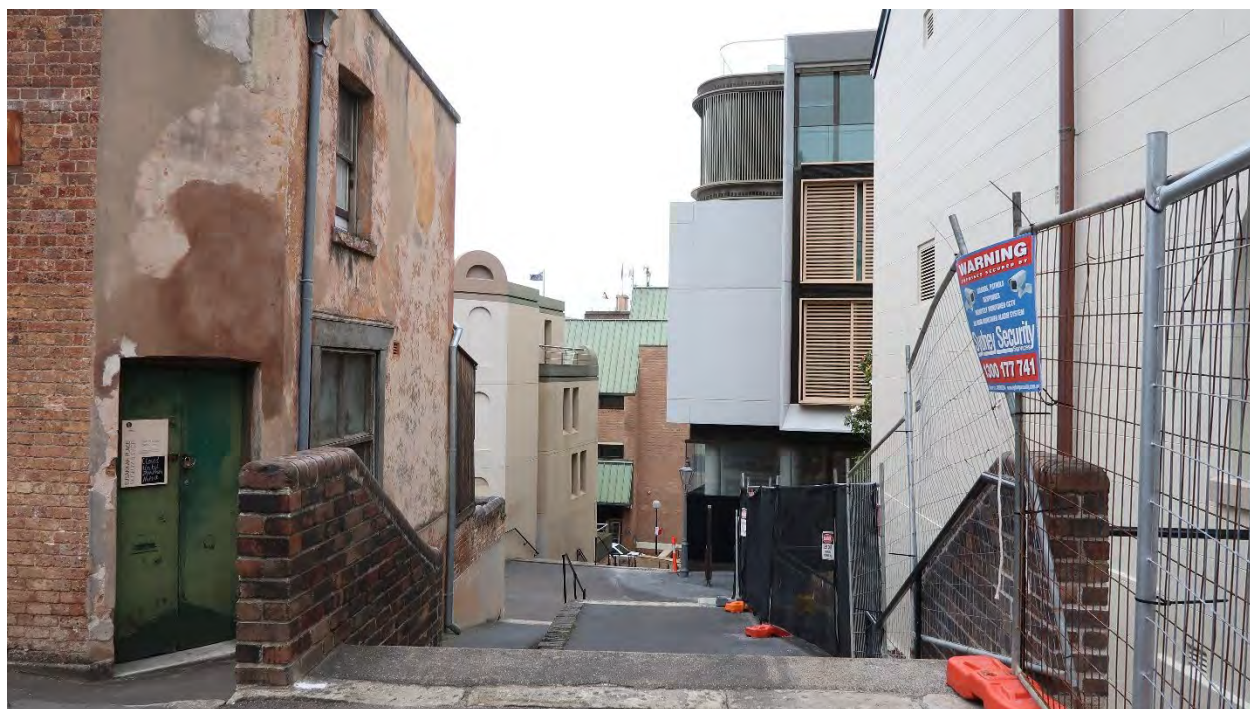
Figure 60 View through Cumberland Place and Steps to Harrington Street from the top of staircase D, Gloucester Street.

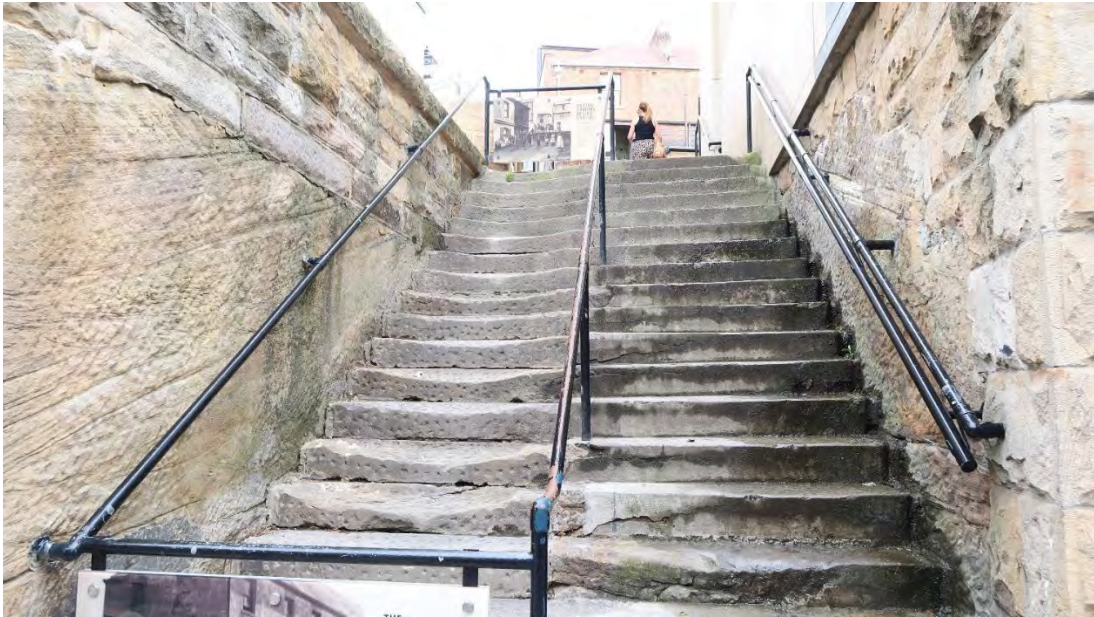
Figure 66 Staircase A. The concrete capping has been removed on the southside but remains on the north.

Cumberland Place comprises four flights of stairs linking Harrington and Gloucester Streets in historic The Rocks precinct. The first flight of staircase A, beginning at Harrington Street, has separate sandstone blocks which have been placed to form steps on the north and south side, and is flanked with tubular aluminium handrails which have been painted black. The left-hand side of the stairs has been cornered off as the treads are substantially worn. Heavy punching to the treads surface, and documentary evidence indicate that these treads would have

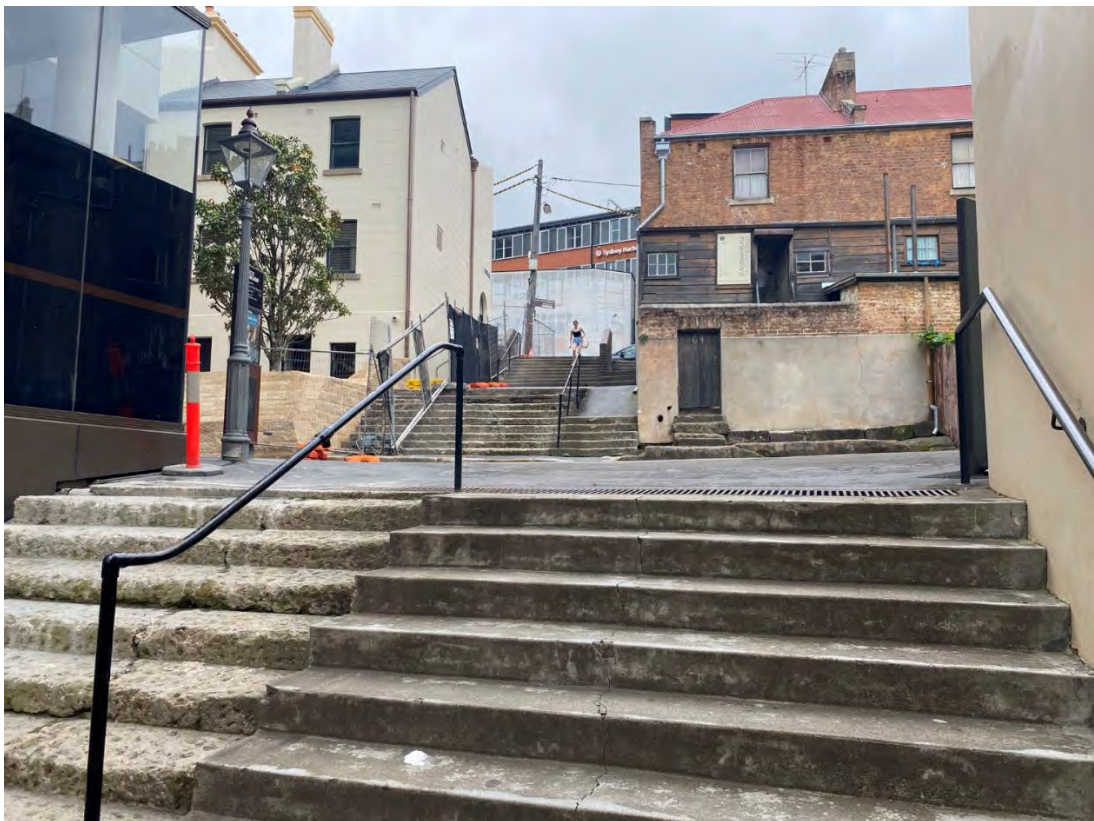
Figure 67 Staircase B. The concrete capping has been removed on the southside but remains on the north.

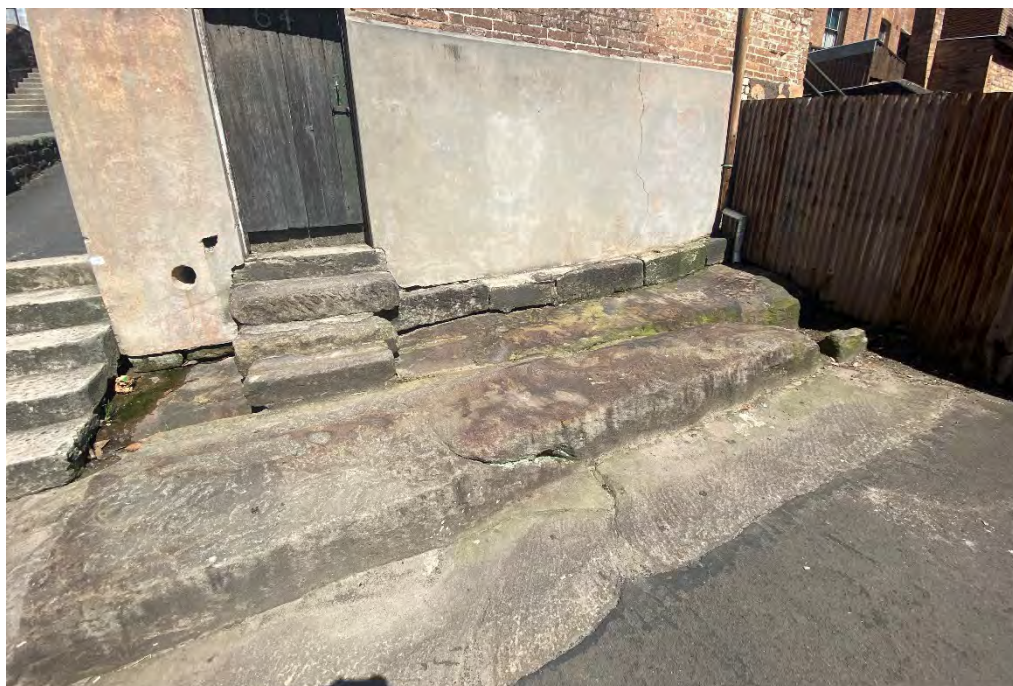
Figure 69 Rocky Sandstone outcrop at the rear of Susannah Place, Cambridge Street.

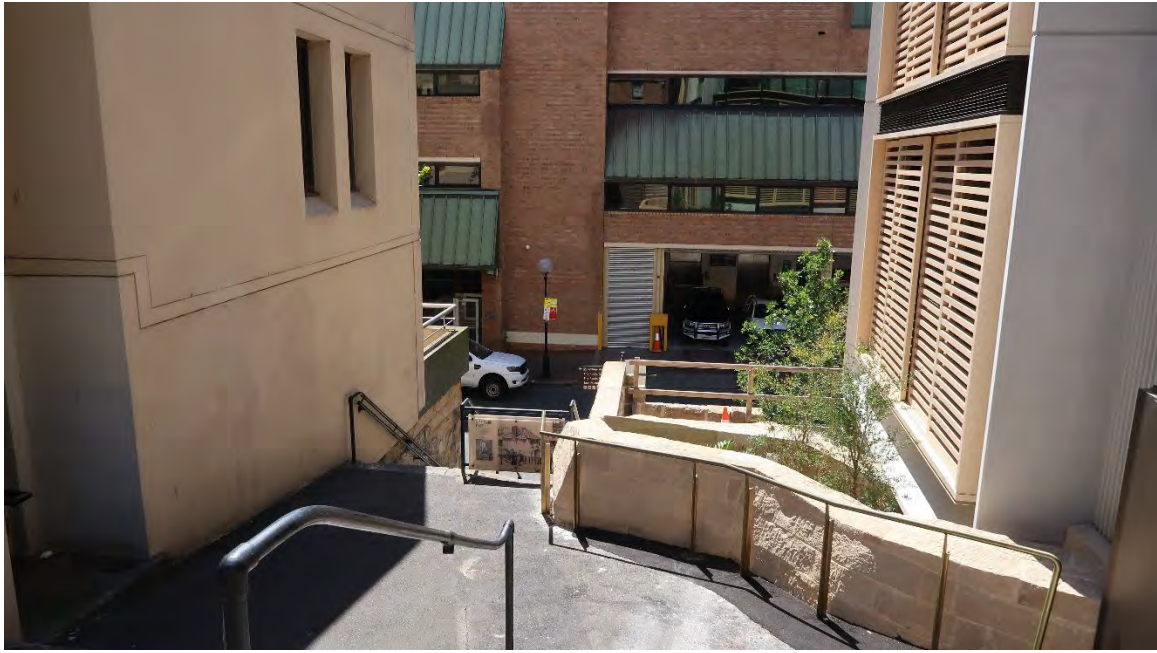
Figure 70 New sandstone wall and landscaping to 85 Harrington Street

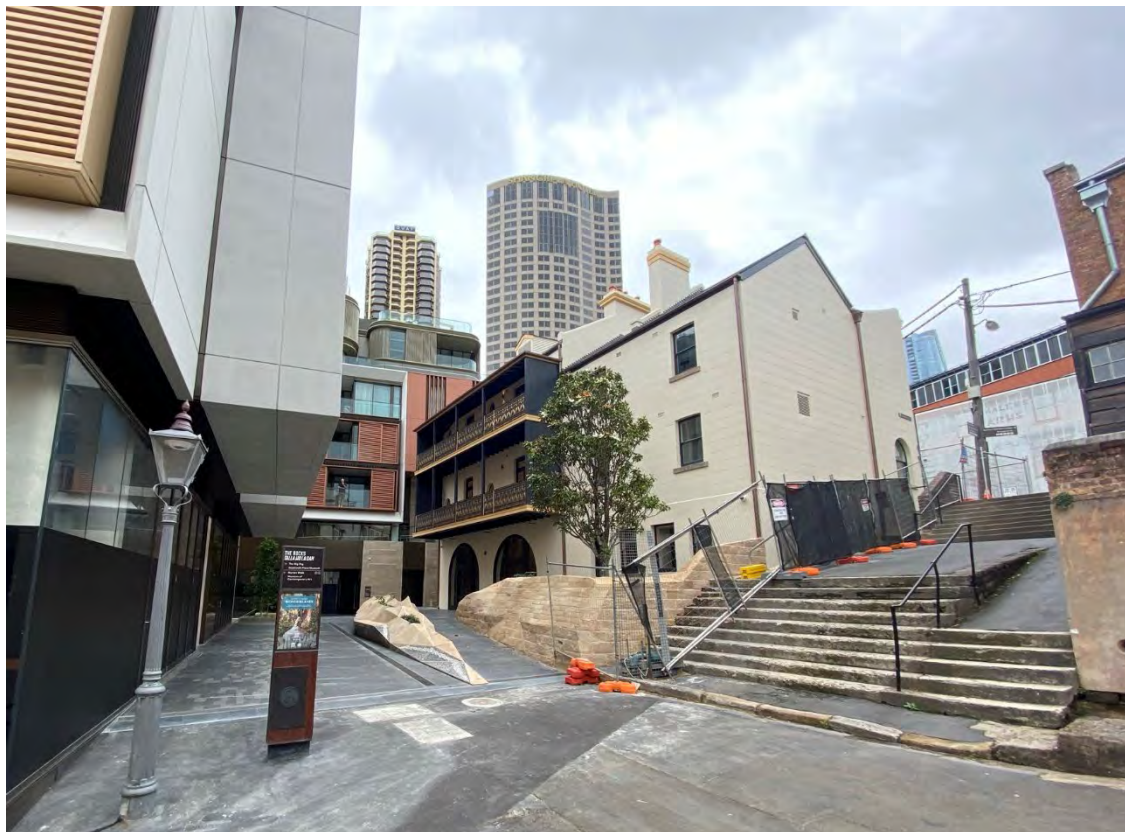
Figure 71 New wall at the rear of Bakers Terrace, now forming the boundary to Cumberland Place and Steps and replica gas lamp.

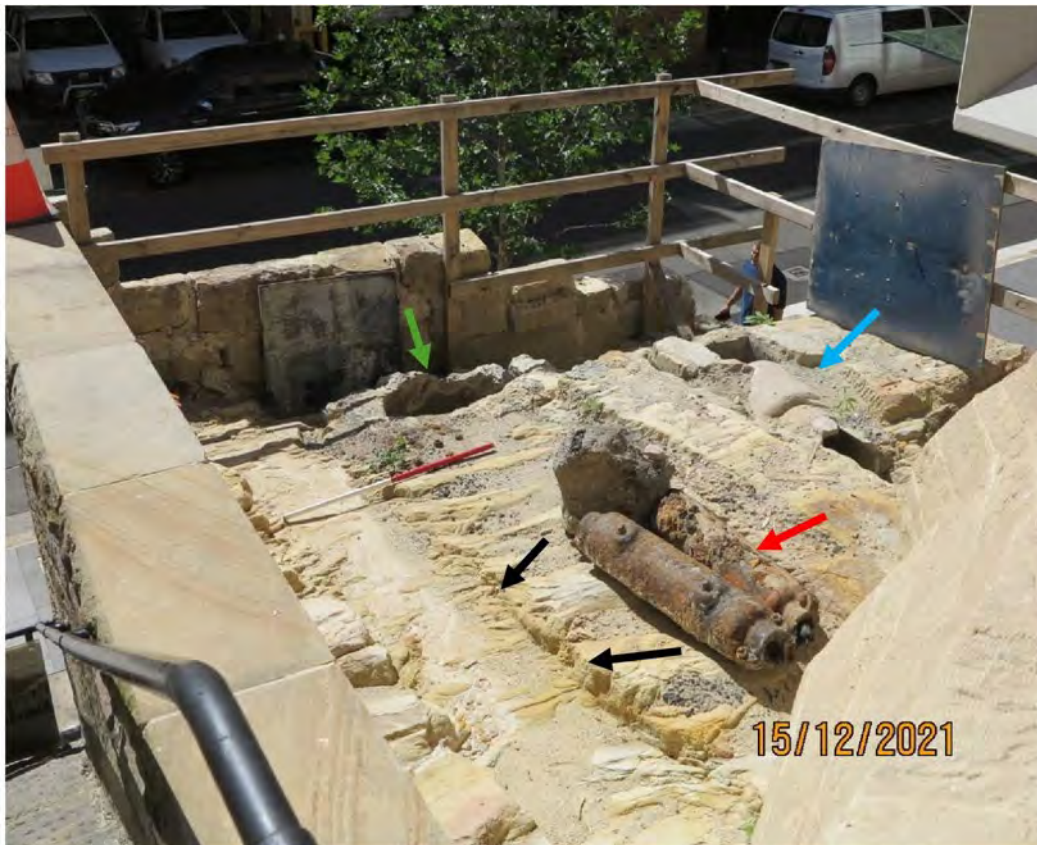
Figure 72 Features identified within the recently excavated garden bed situated behind the sandstone retaining wall along Harrington Street, including stormwater drain (blue arrow), gas pipes (red arrow), and concrete pier base (green arrow). Note the channel through the bedrock where the gas pipe ran (black arrows). View to southeast. Source: Casey & Lowe 2021.

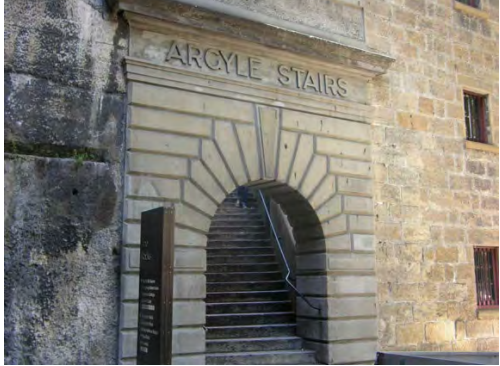
<p data-bbox="226 810 701 863"><i>Figure 74 Argyle Stairs, The Rocks. Source Pocket Guide to Sydney.</i></p>	Argyle Stairs	State (included in the listing Argyle Bridge)	<p>The Argyle Steps are located adjacent the Argyle Cut and like Cumberland Place and Steps was an early thoroughfare with pedestrians ascending natural rock with “some rude steps clumsily excavated in the rock”.²² Historically, The Rocks were divided by rocky outcrop and therefore the thoroughfare was an important connection between both sides of The Rocks and the top of the ridge. A wooden staircase was eventually built which was replaced by the existing stairs in 1911-1912 when the Argyle cut, initially constructed between 1843-1868 to link the two sides of the rocks, was widened.²³</p>

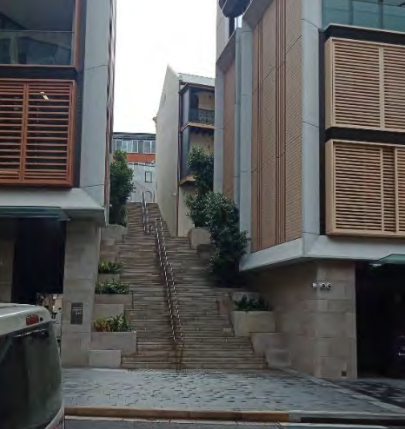
<p>Figure 75 Staircases adjacent Bakers Terrace.</p>	<p>Bakers' Terrace Staircase</p>	<p>None</p>	<p>The staircase is adjacent Bakers Terrace and parallel to Cumberland Place and Steps. The staircase from Harrington Street to Cambridge Street are a contemporary intervention and are associated with the recent development at 85 Harrington Street. The staircase from Cambridge Street to Gloucester Street are historical but its fabric is contemporary. The date of construction is unknown. The staircase is comparable to Cumberland Place and steps for traversing the steep topography between Cambridge and Gloucester Street but they have been substantially altered and formalised.</p>

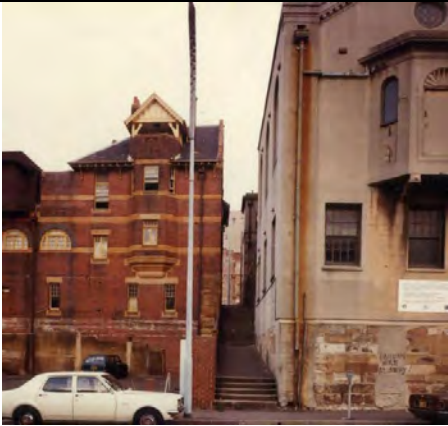
<p>Figure 76 Bethel Steps, 1980. Source: Sydney Harbour Foreshore Authority.</p>	<p>Bethel Steps, The Rocks</p>	<p>State</p>	<p>Bethel steps were constructed in 1907 and replaced Bethel Street. There are three flights of stairs and two asphalt landings. To one side there is a red brick retaining wall which also forms part of the adjacent building. Likewise, there is a sandstone retaining wall on the opposite side. They are comparable to Cumberland place for their composition and formalisation from a street to steps. They also have "some social value for their long-term use as an open, public "right-of-way.""²⁴</p>

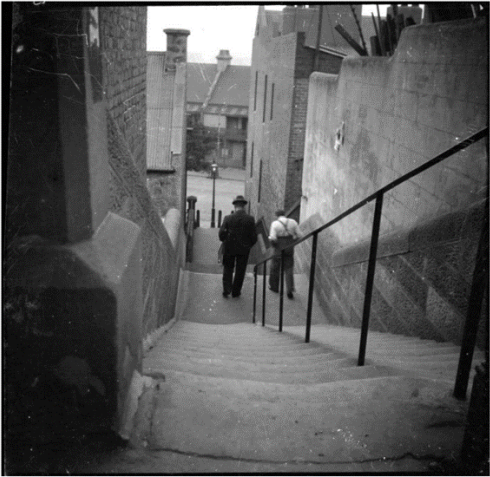
Figure 79 Caraher Stairs between Princes Street and Lower Fort Street. Source: State Archives and Records.

<p>Caraher Stairs</p>	<p>The staircase connected Lower Fort Street, Millers Point to Princes Street North, The Rocks. They were constructed in 1867 and demolished between 1923 and 1932 when Princess Street was demolished to make way for the Sydney Harbour Bridge.²⁵</p>
-----------------------------------------------------------------------------------	------------------------------	--------------------------------------------------------------------------------------------------------------------------------------------------------------------------------------------------------------------------------------------------------------------
