Conservation Management Plan

Cumberland Place and Steps

State Heritage Register 01542

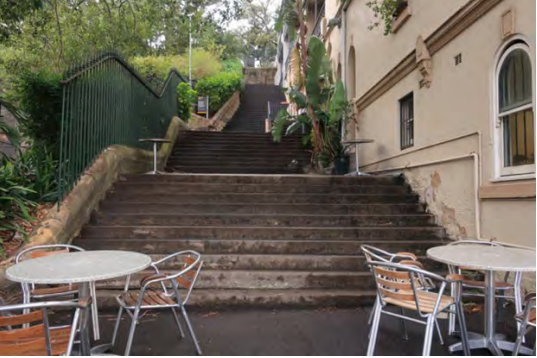
<p data-bbox="197 794 732 906"><i>Figure 80 Agar Steps look up towards Observatory Hill. Source: Splendid Sandwiches – hk L'ourson https://hklourson.com/2018/06/21/splendid-sandwiches/</i></p>	<p data-bbox="763 421 931 528">Agar Steps, Millers Point (1869)</p>	<p data-bbox="992 421 1059 448">Local</p>	<p data-bbox="1135 432 2029 890">Agar Steps, leading off Kent Street, provide access to the western side of Observatory Hill which has historically been a place for viewing the city and leisure. On their southern side the steps are lined with late Victorian Terraces, with their front doors opening onto the stairs, and a sandstone wall with palisade fence to the north which separates the steps from trees and a tennis court. There are two flights of steps separated by a landing before the stairs break off into two branches. The northern branch leads to observatory hill and consists of four flight of stairs and three landings and are lined on either side by a sandstone wall and palisade fence. The southern branch leads to an enclosed space and access to the upper most Victorian Terraces. It consists of two flights of stairs separated by a landing and is lined by a sandstone wall and palisade fence on the northern side and terraces on the south. The Agar Steps are listed as having local significance because of their relationship to the Victorian Terraces which demonstrate “19th century pedestrian networks and urban principles associated with the Millers Point Precinct.”²⁶</p> <p data-bbox="1135 911 2029 1066">It is likely that an informal path existed in the location of the Agar Steps prior to their construction. First built in 1869 and designed by Edward Bell, the City Engineer, the Agar steps have been altered by Adrien Mountain, the City Surveyor, in 1885 and Richard Richards, City Surveyor (1887-1901), in 1892. The current stairs are largely of Richards' design.²⁷</p> <p data-bbox="1135 1086 2029 1168">The formalisation of an informal path, to traverse topography, by the construction of urban elements such as formal steps is comparable to Cumberland Place and Steps. The Agar Steps differ in their relationship to</p>

<p>adjacent buildings. That is, unlike at Cumberland Place the Agar steps act as a street with the primary entrance of the adjacent terraces and shops opening onto the site. Furthermore, the stairway provides access to a particular destination, Observatory Hill, whereas there is no single destination from Cumberland Place and Steps.</p>

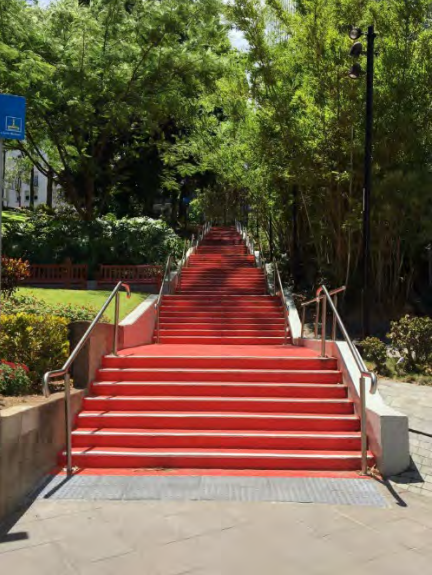
<p>Figure 86 Jacobs Ladder, Brisbane. Source: Foursquare https://foursquare.com/v/jacobs-ladder/4b4cdb4af964a520e9c126e3e</p>	<p>Jacobs Ladder, Brisbane</p>	<p>Local</p>	<p>Jacobs Ladder connects Wickham Terrace and Turbot Street by 10 flights of concrete stairs. It is part of the local listing King Edward Park and Jacobs Ladder as “striking terminus to the vista along Edward Street and has long provided an important and unusual pedestrian connection between the City and Spring Hill.”³³ Prior to the construction of the staircase in 1920 a dirt thoroughfare with handrails existed. The thoroughfare was realigned during the 1920s stair construction.³⁴ Today the staircase is painted red and lined with vegetation on either side.</p> <p>Jacobs Ladder is comparable to Cumberland Place and Steps as a more informal means for traversing terrain was formalised by the creation of a staircase. Furthermore, like Cumberland Place and Steps the site has a social aspect. However, the social aspect though located in a park has been more political as the staircase was historically used as a site for demonstrations.³⁵</p>

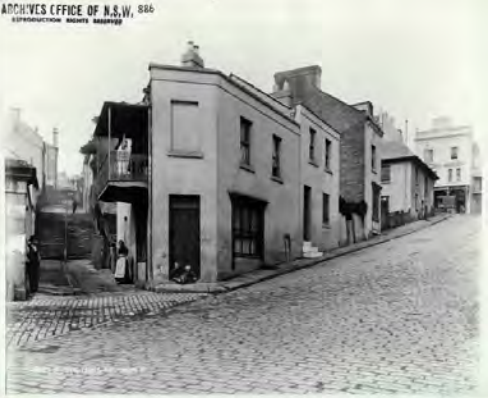
<p data-bbox="212 842 739 957"><i>Figure 87 Historic image of Ferry Lane looking up from Pottinger Street towards Lower Fort Street. Note the staircase which has since been demolished. Source: NSW State Archives and Records.</i></p>	<p>Ferry Lane, c. 1841</p>	<p>Local</p>	<p>The present-day Ferry Lane is a thoroughfare between Lower Fort Street and Pottinger Lane and is intersected by Downshire Street. Historically the lane extended to Walsh Bay and was constructed in conjunction with Pottinger Street in 1841. The lane was lined with cottages, the majority of which were demolished between 1908-1914. The northern end of Ferry Lane was demolished in 1908 for the construction of Hickson Road and the section between Pottinger and Downshire Street was demolished in 1914 and was replaced with the current day park.³⁶ The southern end of Ferry Lane on Lower Fort Street is still lined by cottages.</p> <p>It is comparable to Cumberland Place and Steps for its historical configuration. Historically, there was a staircase in Ferry Lane, however, these were demolished following the construction of the park which flattened the land. Today there is no staircase rather the lane slopes up towards Lower Fort Street.</p>

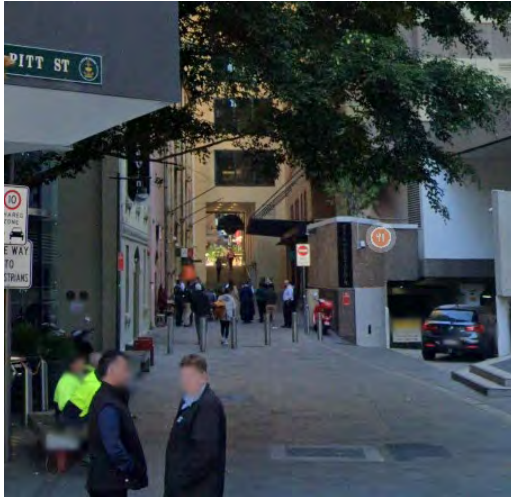
<p>Figure 91 Bulletin Place, Sydney. Source: Google Street View.</p>

<p>Bulletin Place, Sydney</p>	<p>Local</p>	<p>Bulletin Place is a laneway between Pitt Street and Macquarie Place and is listed "for its ability to evidence the development of Victorian Sydney lane networks."³⁷ The lane follows the sloping topography and steeper towards Macquarie Place before flattening on the approach to Pitt Street. It is bound by historic and contemporary buildings. It is comparable to Cumberland Place and steps for its evidencing of early street layouts and responding to rather than changing the natural topography. Unlike Cumberland Place and Steps it does not have defining urban elements such as staircases and landings, and contemporary bollards, paving and the relationship to adjacent buildings give it a more formal aesthetic.</p>

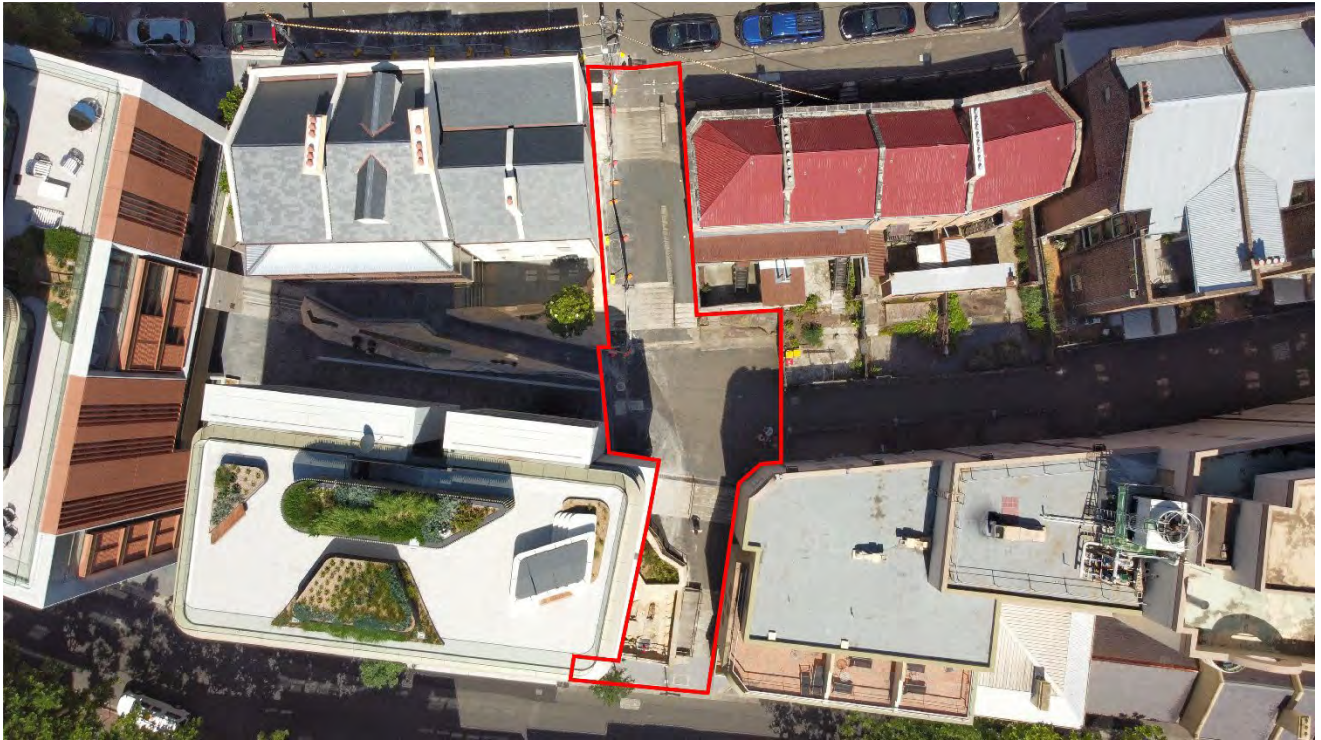
Figure 96 Recommended curtilage.

The recommended curtilage is extended to include the kerbs on Harrington and Gloucester Street, the rear boundary of Susannah Place, and the sandstone retaining wall along Harrington Street. See Figure 96 below.
