TARWYN PARK & ITS SETTING
Upper Bylong, NSW
Heritage Significance Assessment

Prepared for
The NSW Office of Environment
and Heritage
Version V1.2 – 22 February 2018

Tarwyn Park & Its Setting
Heritage Significance Assessment V.1.0
Was prepared by
Hector Abrahams Architects Pty Ltd
Studio 402, Reid House
75 King Street
Sydney NSW 2000

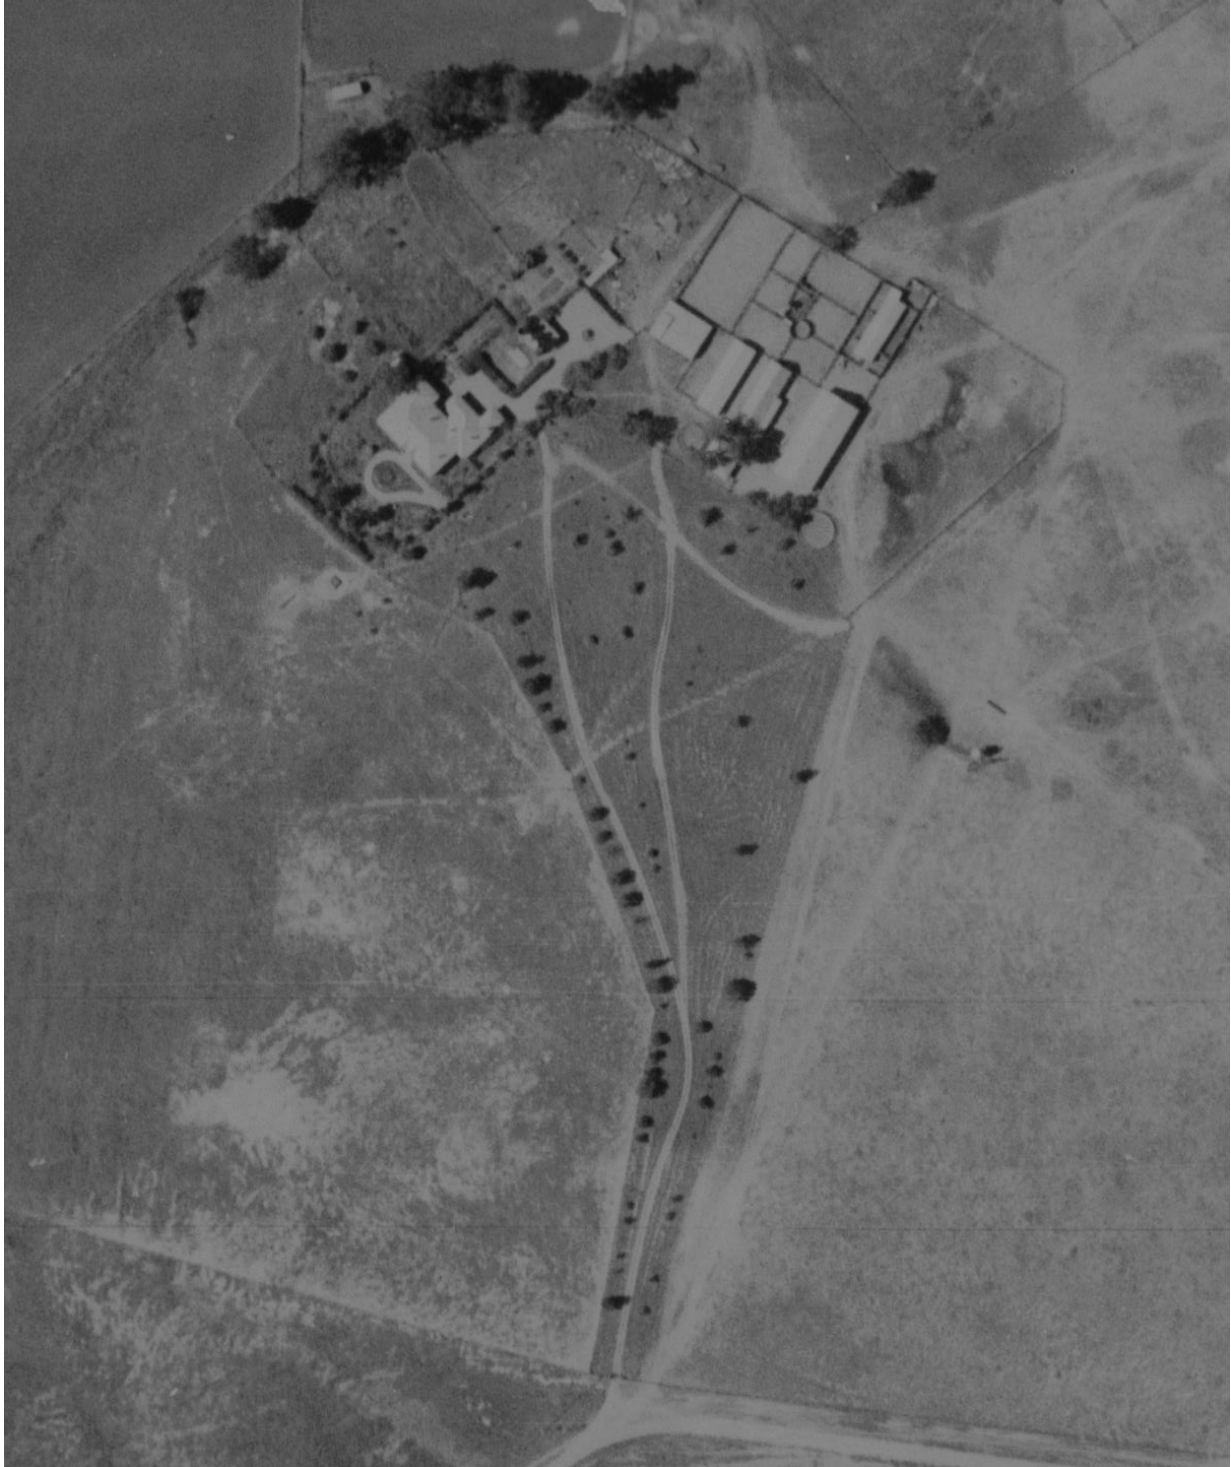
Figure 1: Detail of 1944 aerial photograph showing Tarwyn Park.
(Source: United Photo & Graphic Karrabee 2 April 1944, Film MAP535, Run 8, frame 100666)

The documentary and field research has found some evidence of former buildings on the place, but no other major structures. The 1944 aerial photograph offers substantial evidence of the landscape design of the driveway space, the rear spaces around the homestead and the front garden.

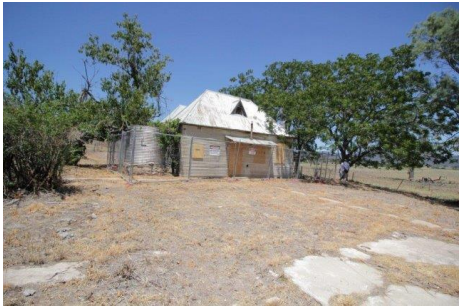
Item #	Inventory Item	Short Description	Date	Signif. Grading	Notes
AREA 1: Iron Tank Homestead and surrounds (refer Figure 7)					
1.1	Iron tank homestead	Single storey cottage ornee. Clad in galvanised corrugated iron on roof and horizontally on walls. Steep pitched roof with pair of matched timber gablets with turned finials on rear and front slopes. Evidence of verandah floor on west rear side. Timber framed, hardwood stumps cypress frame. Stone chimney to eastern front side, sparrowpicked and margined rough ashlar. Awning over rear door and window. Chamfered timber verandah framing at front. No evidence externally of successive builds. Concrete and pipe on verandah at front post 1945.	Early twentieth Century L	Exceptional (Local)

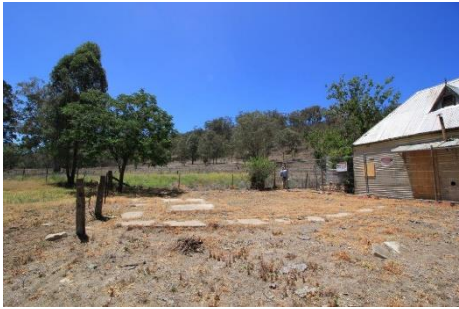
Item #	Inventory Item	Short Description	Date	Signif. Grading	Notes
1.2	Cement floor slab	Cement slab with cast in upstand for sewer	Mid twentieth Century	Little

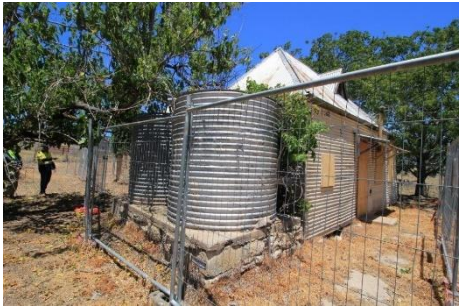
1.3	Tank Stand	Pair of galvanised steel tanks on stone stand	Early twentieth Century L	Exceptional (Local)

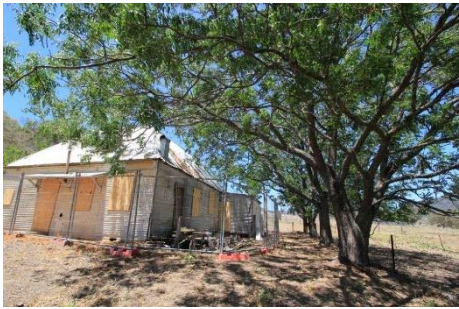
1.4	Row of four White Cedar trees	Four mature trees on western fence line	Early twentieth Century L	Exceptional (Local)

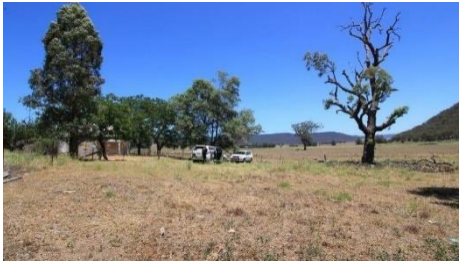
Item #	Inventory Item	Short Description	Date	Signif. Grading	Notes
1.5	Sheoak	Large mature tree in corner of yard	Early twentieth Century L	Exceptional (Local)

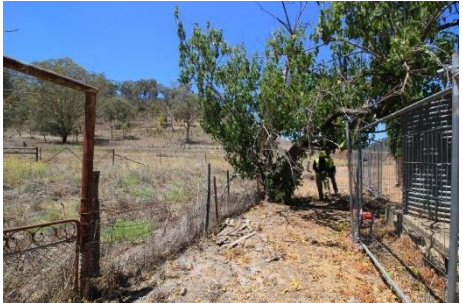
1.6	Mulberry Tree	Large mature tree on east side of house	Early twentieth Century L	Exceptional (Local)

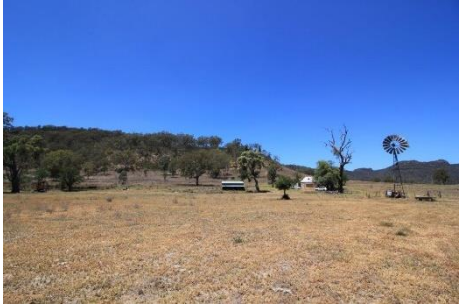
1.9	Windmill	"Southern Cross" windmill, cast cement water trough plumbed in	Post 1945?	Needs further analysis

1.10	Eucalypt	Mature very significant dieback	L	Exceptional (Local)	Refer to image for 1.9
1.11	Eucalypt	Mature significant dieback	L	Exceptional (Local)	Refer to image for 1.9

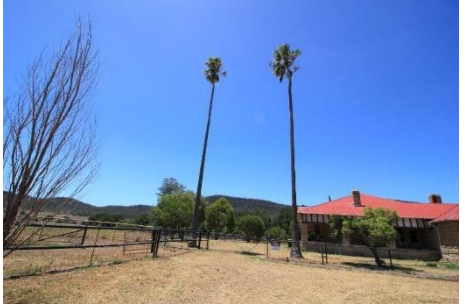
2.4	Stump of large wisteria & stump of rose bush (dead)	Against corner of veranda	T?	Exceptional (Local)

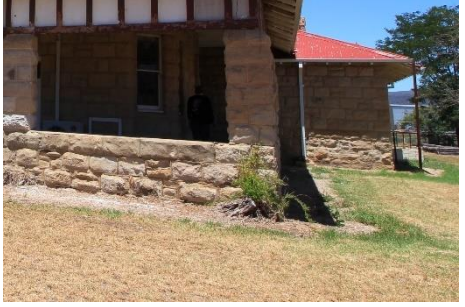
2.5	Stump of Rosebush	Dead	T?	Exceptional (Local)	Refer to image 2.4

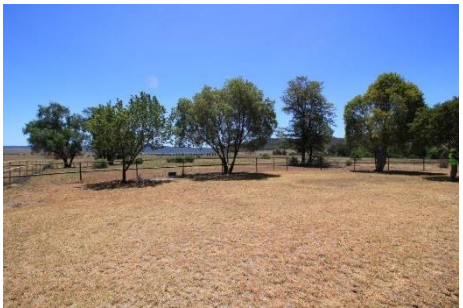
2.7	Spirea	This durable hedge plant is on the alignment of the front garden enclosure shown in the 1944 Photograph	T	Exceptional (Local)	Exceptional (Local)
2.8	Fruit Tree	Mature. This may be part of the garden enclosure shown in the 1944 photograph	T?	Exceptional (Local)

2.9	Callistemon	Mature	A	Little	Refer to image 2.8
2.10	Melaleuca	Mature	A	Little	Refer to image 2.8

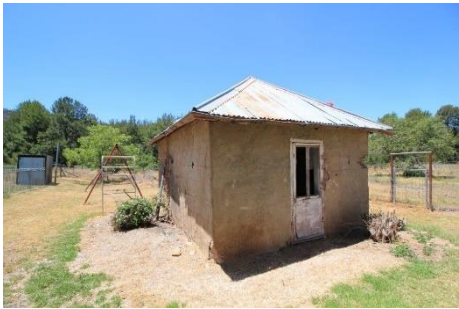
Item #	Inventory Item	Short Description	Date	Signif. Grading	Notes
2.21	Meat room?	Rectangular single room with one door, under hipped roof, deep eaves, clad in corrugated galvanised steel. Ogee gutters, walls of Pise de Terre, hardwood floor laid on ground, plastered walls internally.	T	Exceptional (Local)

2.22	Plants around outbuilding	Unidentified shrubs on east, north and west side, vine on north and east	A	Little	Refer to image 2.21
2.23	Tree Stump		Not assessable	Little

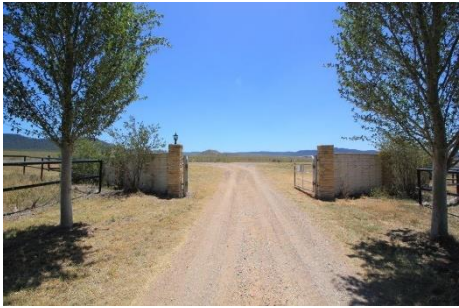
Item #	Inventory Item	Short Description	Date	Signif. Grading	Notes
2.29	Number not used				
2.30	Line of drive	Curved sweep leading off diagonal junction of Upper Bylong Road	T	Exceptional (Local)

2.31	Stone gate bulwarks	Split stone.	A	Intrusive	Refer to image 2.30
2.32	Cotton wood poplar avenue	On line of drive, these obscure the landscape space of the driveway as shown in the 1944 Photograph	A	Intrusive

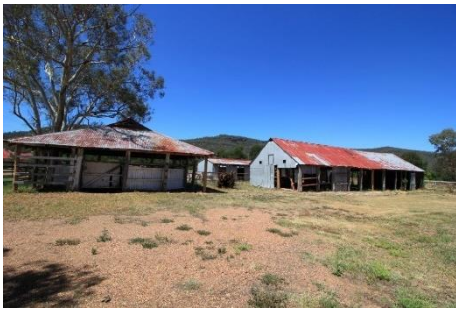
Item #	Inventory Item	Short Description	Date	Signif. Grading	Notes
2.43	Horse Stalls building	Timber posted bush pole construction, gabled roof, evidence of slotted rail system, concrete floor marked out in squares, cement apron on west side outside building	T	Exceptional (local)	Refer to image 2.42
2.44	Horse loose box building	Gabled stud framed timber with central posts supporting ridge, containing eight loose boxes opening to east and eight opening to west, gabled roof clad in corrugated galvanised steel, vented ridge, D profile gutters, framed and sheeted horse doors in two leaves per stall	T	Exceptional (local)

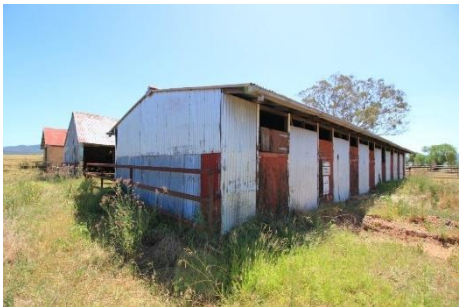
2.45	Machine shed	Large steel posted open to south, skillion roof, walls clad in vertical Zincalume ribbed sheeting, adjacent water tank to north east. Placed on site of earlier building	A	Little
